NON-DESTRUCTIVE TESTING OF THE SANCTUARY OF VICOFORTE

Abstract

Non-destructive test, Diagnostic inspection, Deterioration, Sanctuary of Vicoforte

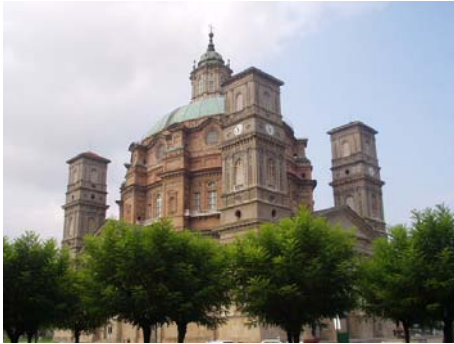
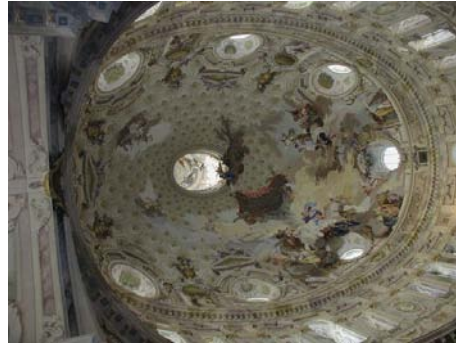
Figure 1 The Sanctuary of Vicoforte

(a) External view

(b) Internal view

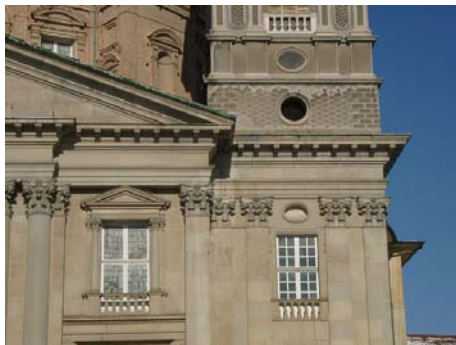
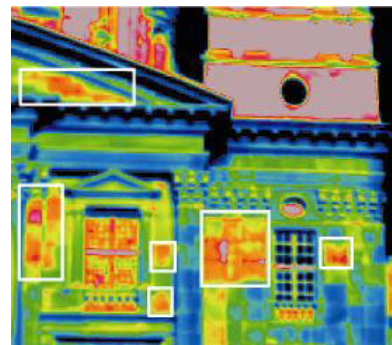
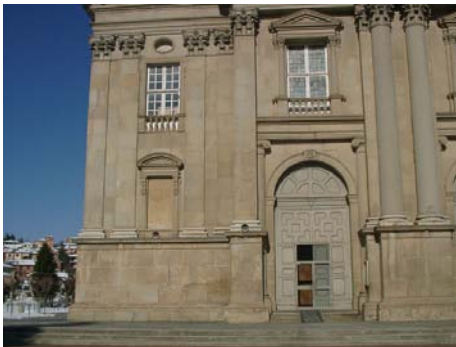
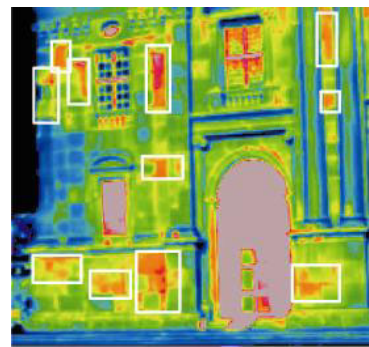
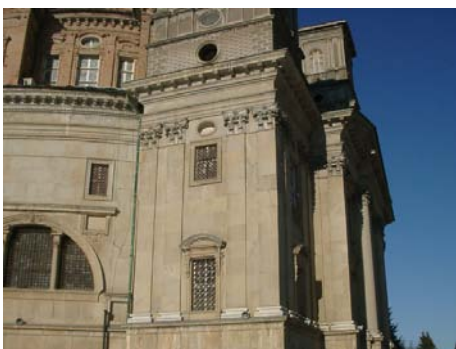
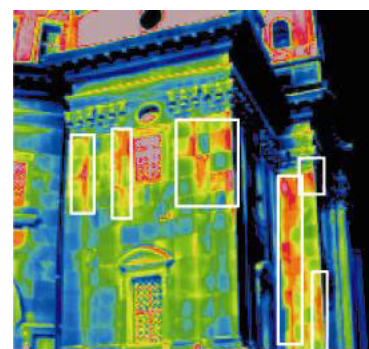
Figure 2 Delamination of stone finishing

In order to detect defects such as delamination and water leakage, Radiation Thermometer is applied (Komiya et al 2002). Delamination of stone finishing at both south and west sides are seen in the rectangular areas in Figure 2. The state of delamination of stone finishing is very dangerous, and this means that some measures should be taken against it.

(a) Visual image at south side

(b) Thermal image at south side

(a) Visual image at west side

(b) Thermal image at west side

- Delamination of stone finishing and fresco painting by means of Radiation Thermometer: The state of delamination of stone finishing is very dangerous,

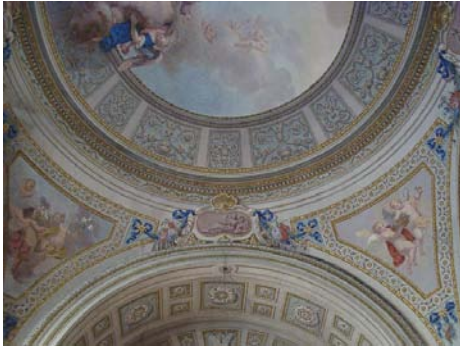
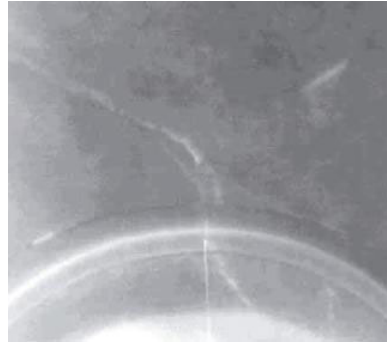
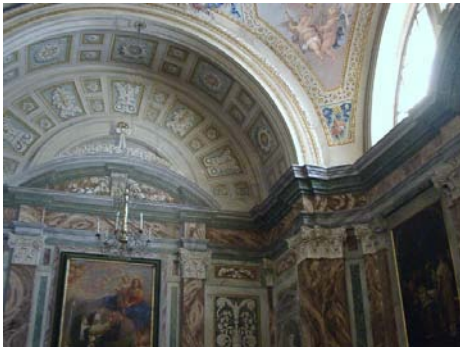
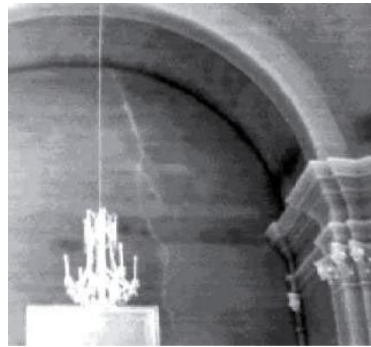
Figure 3 Delamination of fresco painting in the northwest chapel

As for the detection of delamination and/or water leakage of fresco painting, active heart source are used. Figure 3 shows delamination of fresco painting in the northwest chapel. Delaminations of fresco painting of the main dome at both north and west sides are shown in Figure 4.

(a) Visual image

(b) Thermal image

hence some measures should be taken against delamination. A lot of delaminations of fresco painting are detected at the dome cornice level and at chapels.

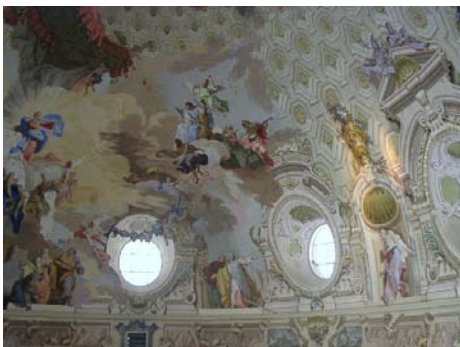
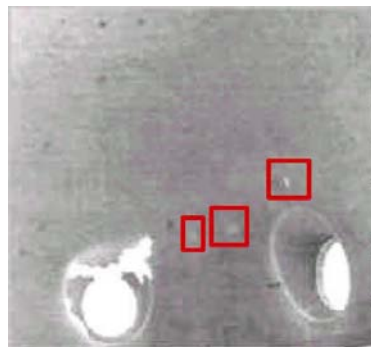
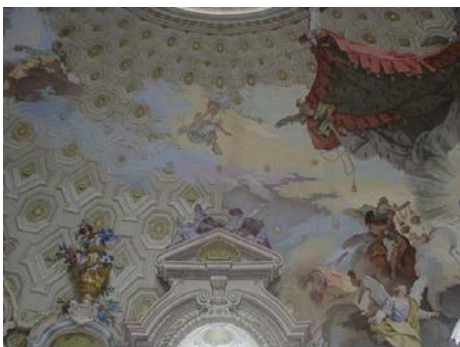
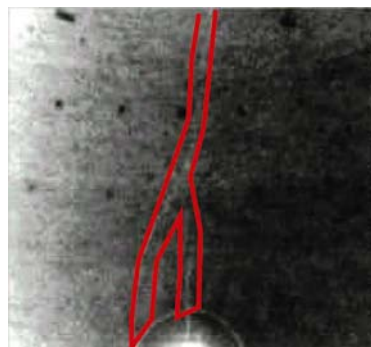
Figure 4 Delamination of fresco painting of the main dome

(a) Visual image at north side

(b) Thermal image at north side

(a) Visual image at west side

(b) Thermal image at west side

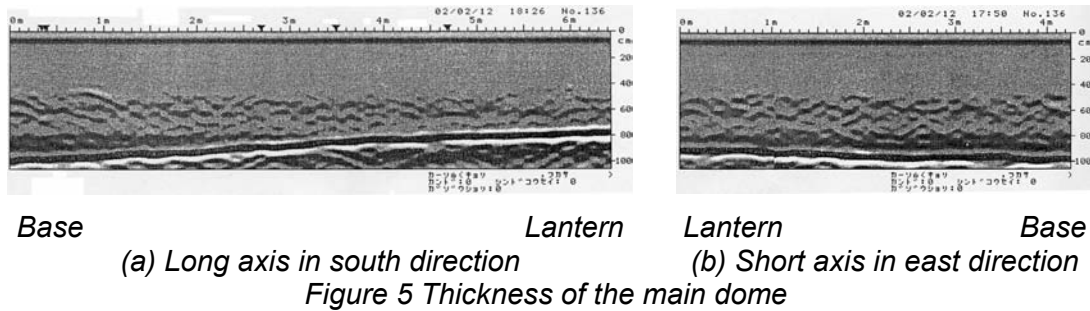
Figure 6 Thickness of the vault over chapel

Electromagnetic Radar is applied in order to estimate the thickness of the main dome and vaults over chapels (Komiyama et al 2002). Because of the difference of dielectric constant between concrete and masonry, a provable test of masonry wall over apse is carried out; and the correction factor of 1.33 is obtained by the fact that thickness of the wall which is measured 60 cm by Radar turns out to be 80 cm. As shown in Figure 5, the thickness of the main dome in south and east directions are measured from 110 cm to 133 cm and from 120 cm to 133 cm, respectively. These results correspond well to those measured by Eng. Bernasconi in 1976 (Bernasconi 1979). The minimum thickness of the vault over chapel is measured about 30 cm (Figure 6).

- Thickness of main dome and vaults over chapels by means of Electromagnetic Radar: The results obtained from our research correspond well to those measured by Eng. Bernasconi in 1976.

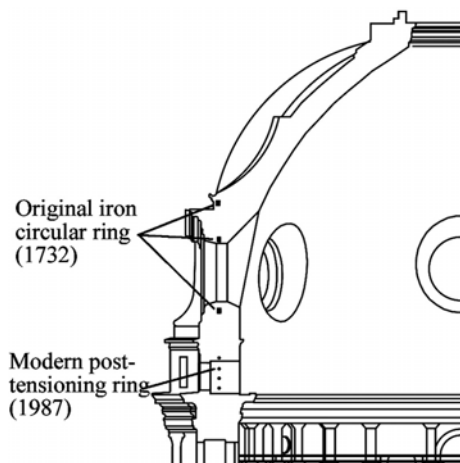
Figure 7 Position of reinforcement

In order to detect the presence of iron reinforcement, Electromagnetic Radar, and Electromagnetic Induction Scanner are applied (Komiya et al 2002). Three sets of iron rings embedded at the base of the main dome by Eng. Gallo in 1734 are observed (Figure 7). No other annular reinforcements, however, are detected in the dome with the exception of the post-tensioning steel ties inserted at the base of the drum in 1987 (Figure 7). This confirms that the additional reinforcement by iron rings proposed by Eng. Garro in 1961 has not been actuated (Garro 1962).

- Detection of reinforcement by means of Electromagnetic Radar, and Electromagnetic Induction Scanner: No other annular reinforcements are detected in the dome with the exception of the system of prestressing steel ties inserted in 1985.

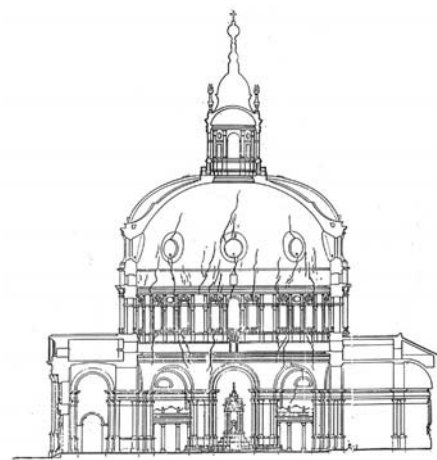
Figure 8 Cracks at west side

Our measurement of subsidence of ground level and dome cornice level verifies that there is a little difference between the measured values and those measured by Eng. Garro from 1935 to 1945 (Figure 11) (Garro 1962, Ohashi et al 2003). The subsidence is bigger in the northwestern direction, and differential settlement occurs towards this direction. This tendency corresponds to the occurrence of the enormous crack of the wall surface as well (Figure 8).

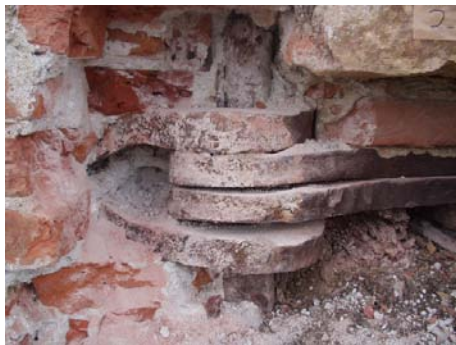
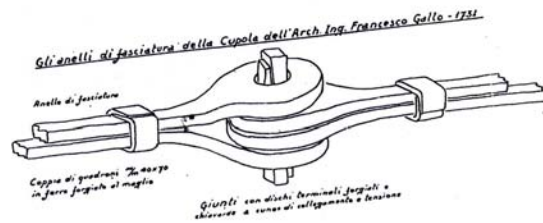
Figure 9 Iron ties embedded at the base of the main dome by Eng. Gallo

There are three sets of iron ties embedded at the base of the main dome by Eng. Gallo in 1734 (Figure 9). During and after construction, plastic deformation of the dome occurs, the materials separate into blocks, slippage begins, fractures develop, and the discontinuous deformation begins due to many reasons including dead load, differential settlement, temperature stress, and also chemical degradation (Figure 8). In order to estimate the continuity of these iron ties, Impact Echo Scanner is applied (Komiyama et al 2002). A sensor of longitudinal wave type is used here. The total length of the iron ties is around 104 m. As the sound velocity of iron is about 5,000 m/sec, one circuit time should be around 0.0208 second. As shown in Figure 10, these iron ties are probably continuous. As to the iron reinforcements, it is interesting to note that those embedded at the base of the dome of San Pietro have been broken.

(a) Original iron tie

(b) Detail of iron tie

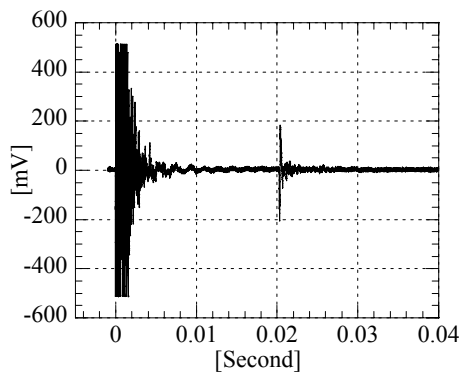
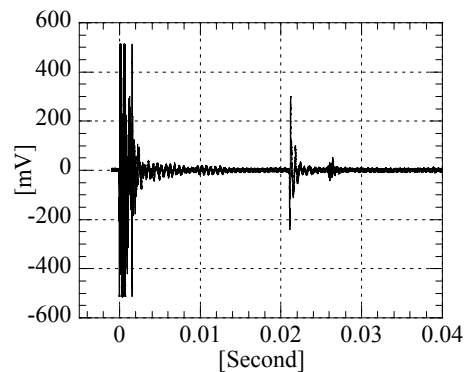
Figure 10 Wave profile of received elastic wave

(a) First ring of iron ties

(b) Second ring of iron ties

- Continuity of iron ties embedded at the base of the dome by Eng. Gallo by means of Impact Echo Scanner: First set of iron ties is continuous in the west side of the dome. Therefore these iron ties are probably continuous.

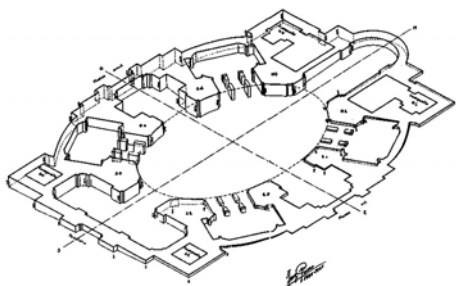
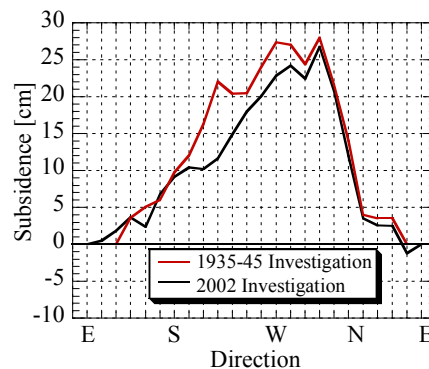
Figure 11 Level survey

(a) Subsidence by Garro

(b) Ground level (outside)

- Measurement of subsidence of ground level and dome cornice level: There is a little difference between our measured values and those measured by Eng. Garro from 1935 to 1945.

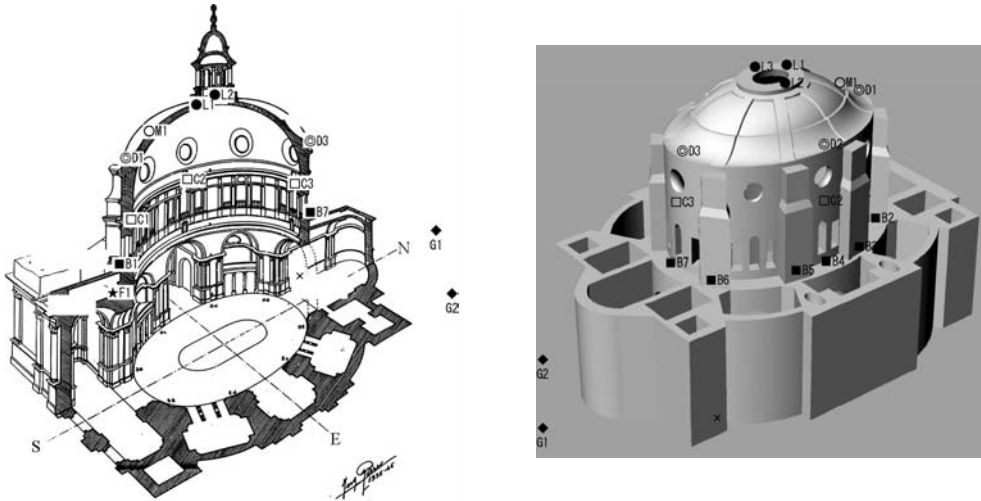
Figure 12 Measuring points of ambient vibrations

For the purpose of obtaining the data concerning dynamic structural properties of the Sanctuary of Vicoforte, microtremor by ambient vibrations are measured at different positions of the dome, inside and outside the Sanctuary, as a first phase of dynamic test (Figure 12) (Aoki et al 2003). Smoothed spectra by Parzen's spectral window of 0.5 Hz are given in Figure 13. In Figure 13, bold solid line, bold dotted line and fine solid line show the spectra of north-south, east-west and vertical directions, respectively. According to the observation of microtremor by ambient vibrations, fundamental frequencies in north-south and east-west directions are estimated to be 2.12 and 1.95 Hz, respectively (Figure 13). The fundamental frequency of the dome of the Sanctuary of Vicoforte is close to that of ground motions when earthquake occurs. The dome of the Sanctuary of Vicoforte, therefore, seems to be most vulnerable to the kind of strong earthquakes such as we experienced in recent years.

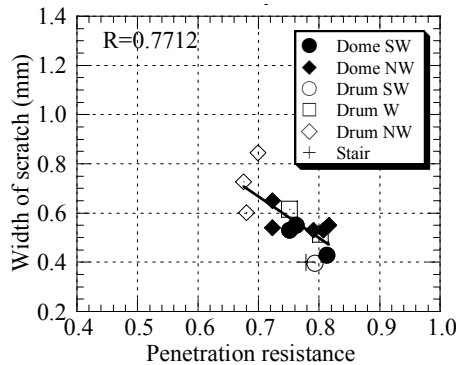
Figure 14 Relationship between width of scratch and penetration resistance

Results of laboratory tests of the brick are shown in Figures 14 to 17. Figure 14 shows the relationship between width of scratch and penetration resistance. Judging from these Figures, it is verified that there is a good correlation among the outcomes of the tests. Figures 15 and 16 show the relationship between compressive strength and width of scratch and penetration resistance. As the width of scratch becomes larger, compressive strength becomes lower. On the other hand, as the penetration resistance becomes larger, compressive strength becomes higher. The relationship between compressive strength and Young's modulus is shown in Figure 17. As the compressive strength becomes higher, Young's modulus also increases proportionally.

- Estimation of compressive strength for the brick and the mortar by means of Scratch Tester and Windsor Pin System: There is a good correlation among compressive strength and scratched width and penetration resistance.
